WaterOne
Water District No.1 of Johnson County

2 1/2 INCH OR LARGER DOUBLE CHECK DETECTOR ASSEMBLY (DCDA) W/MIU	
FOR FIRE SERVICES	
DRAWN BY: WRY DATE: 11-11-13	DWG NO. ES-1816

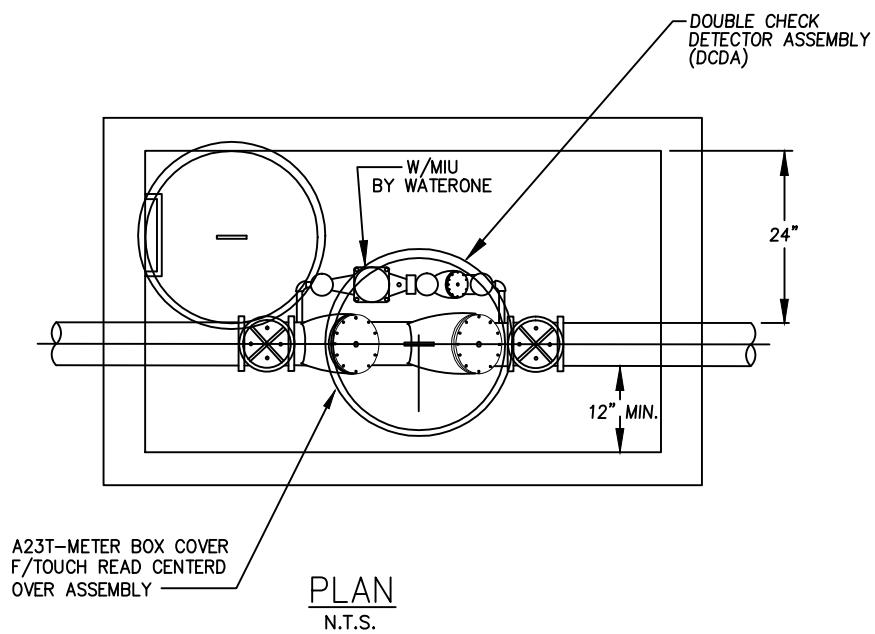
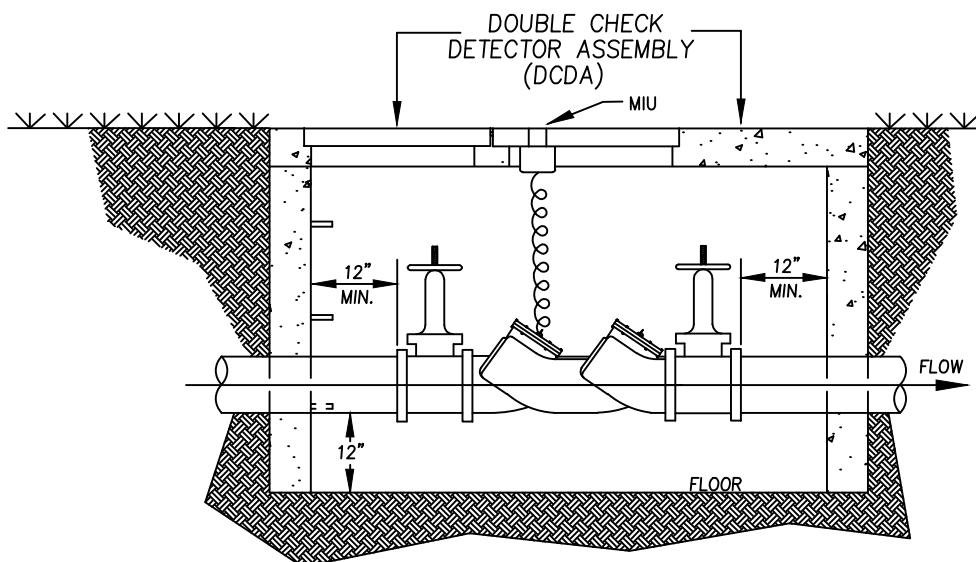
1. THIS DRAWING IS ONE EXAMPLE OF A VAULT SHOWING CLEARANCES AROUND THE DCDA AND IS NOT TO BE CONSIDERED A WATERONE STANDARD.
2. VAULT, COVER AND LADDER SHALL BE DESIGNED BY OWNER/AGENT.
3. REQUIREMENTS AND SPECIFICATIONS ARE SUBJECT TO CHANGE WITHOUT NOTICE.
